# Home Inspection Report

**988 Boulevard of the Arts Unit #109  
Sarasota, FL 34236**

## General Information

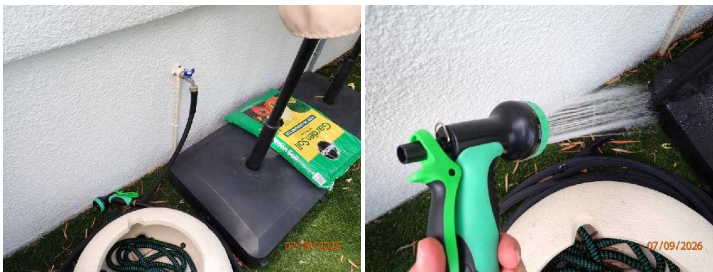
Hose Bibs: brass

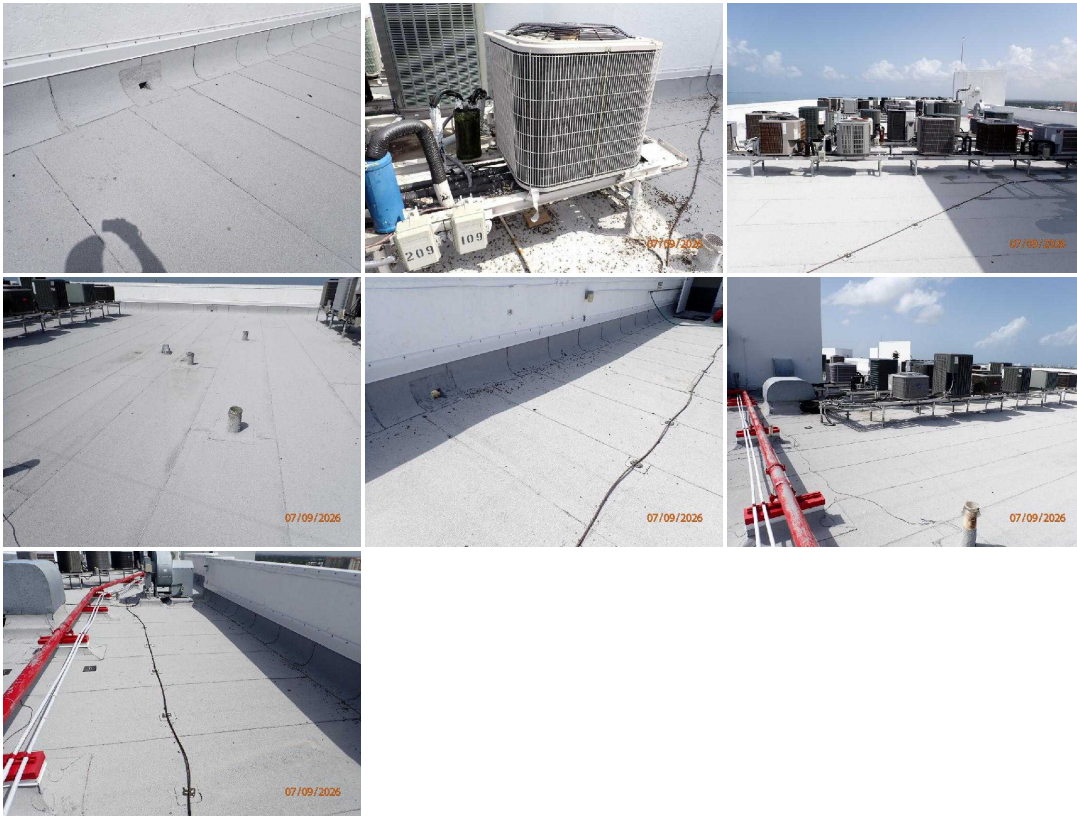
4. Acceptable Material: Built-up, modified bitumen - Roof material (modified bitumen) build up, useful life is approximately 20 years.

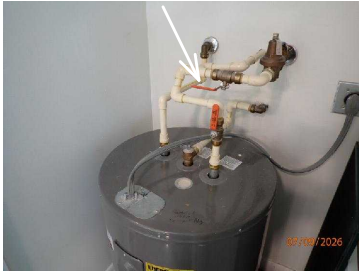
3. Acceptable Main Water Shutoff: above hot water tank

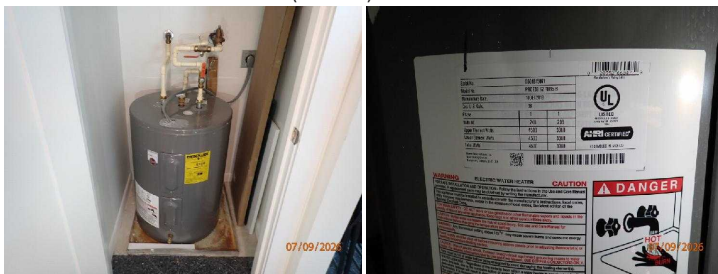
9. Manufacturer: Rheem (2019)

10. Model Number: PROE38 S2 RH95 Serial Number: Q501815061

11. Type: Electric Capacity: 38 gal.

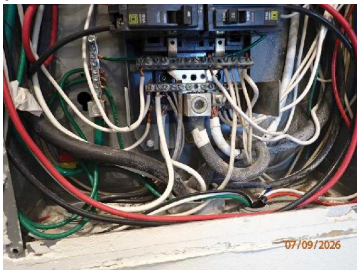
2. Acceptable Service Entrance Cable: Aluminum stranded, copper stranded - Main disconnect is located at the panel unless otherwise noted.

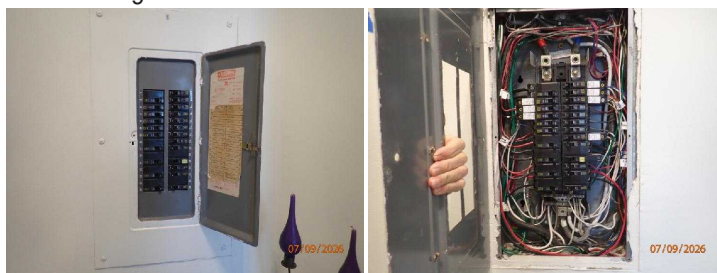
9. Acceptable Manufacturer: Square D - Service Electrical Panels average life span 30-40 years. Electric panel looked in good order.

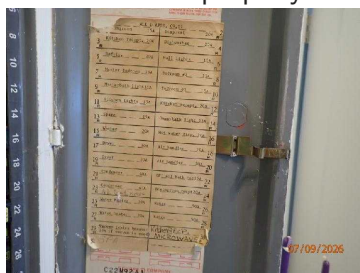
11. Acceptable Panel Labeled: properly labeled

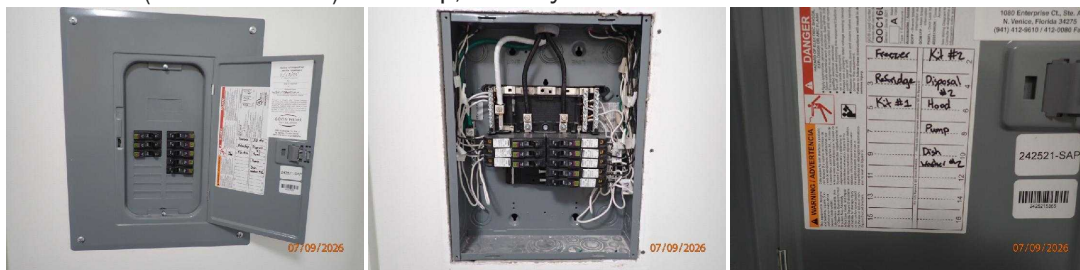
13. Acceptable Sub Panel (Sz. & Location): 40 amp, laundry room

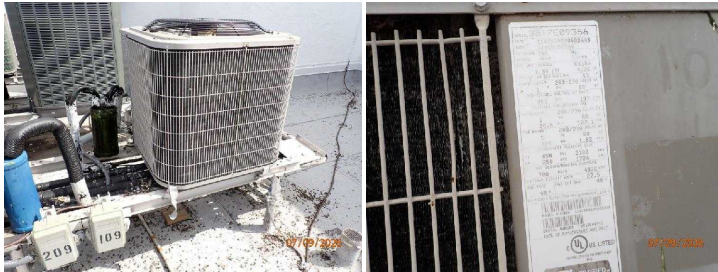
1. Acceptable #1 A/C System Operation: Appears serviceable, Functional - AC Condenser has an approximate life span of 8-12 years.
2. Acceptable Condensate Removal: PVC
3. Area Served: Whole condo unit Approximate Age: 8 years AHU, 8 years condenser
4. Fuel Type: 208-230 volts Temperature Differential: 78-57= 21 degrees, good
5. Type: A/C with heat strip Capacity: 5 Ton
6. Acceptable #1 Exterior Condenser Unit: anchored on metal railings on roof
7. Condenser Manufacturer: Bryant (2018)

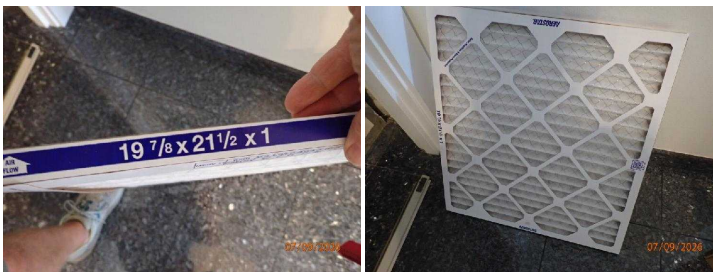
21. Acceptable Filter: clean

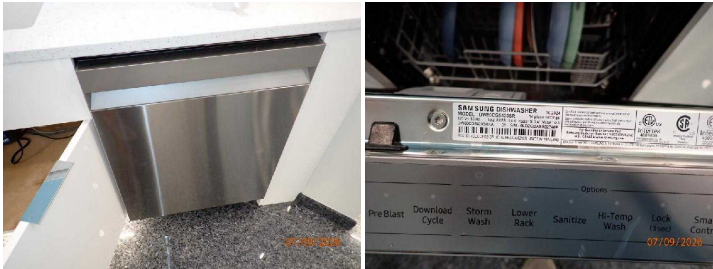
Dishwasher: Samsung

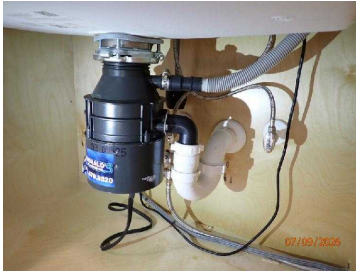
12. Acceptable Plumbing/Fixtures: PVC, braided stainless steel, Nylon, PEX
